**USAAVLABS TECHNICAL REPORT 70-46**  
**DESIGN CRITERIA FOR AN INSPECTION AND DIAGNOSTIC  
SYSTEM FOR THE UH-1D HELICOPTER**

**Joseph C. Leifer**  
**Harold G. Peacock**

**November 1970**

**U. S. ARMY AVIATION MATERIEL LABORATORIES**  
**FORT EUSTIS, VIRGINIA**

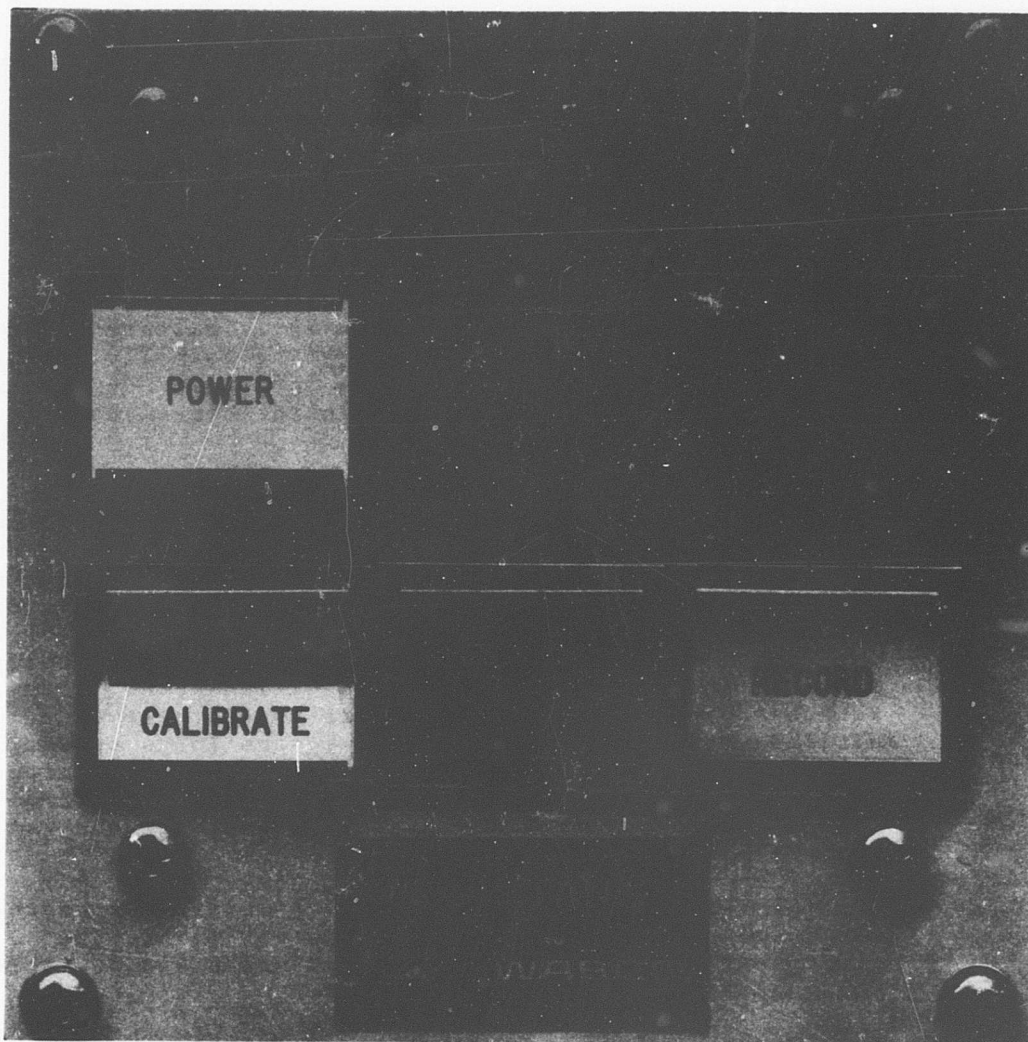
Figure 5. Front View of Pilot's Control Panel.

1. An illuminated alternate-action power switch is provided to actuate the recording system. Turning power ON or OFF places the recorder and logic system

in the CALIBRATE mode for 24 seconds. During final CALIBRATE, before the equipment shuts off, the power switch is illuminated RED rather than the normal WHITE.

4. Malfunction Button -- This button illuminates in the event that the recorder drive system does not establish an on-speed or phase-lock condition within the 4-second interval allowed before data recording begins. If the recorder should achieve phase-lock at the beginning of recording and should drop out instantly six times or continuously for six seconds, the system stops recording, and the malfunction button is illuminated. Because the recording of good data under these conditions would be impossible, the system locks up until a successful calibration run is performed. The latter can be attempted by either depression of the calibration button or malfunction button, or removal and reapplication of power.

5. Waiting Straight and Level Lamp -- After runout of the 15-minute timer, if the aircraft is not within the prescribed torque, attitude, and airspeed window, this yellow lamp indicates that condition.

6. Push Record Button -- Depression of this button initiates a 12-second data recording interval regardless of the condition of the flight window. Whenever the recorder is operating, the record lamp is lit. However, no recording will occur if the malfunction lamp is lit.

Because of the requirement that data be collected on the ground before and after flight, and because it might occasionally be desirable for the pilot to disable the power bus to the data collection system, it was necessary to provide a pilot's control panel. The console between instructor and student had several blank areas on all the helicopters examined, and this appeared to be a highly satisfactory location for this element. The airborne system was designed to collect data at intervals only when the aircraft was in the desired flight window or during ground run-ups. It was deemed desirable to provide a subtle hint to the pilot when the equipment was waiting for straight and level conditions in order to record. Several other controls and displays were added, and the resulting panel features are outlined below (see Figure 5).

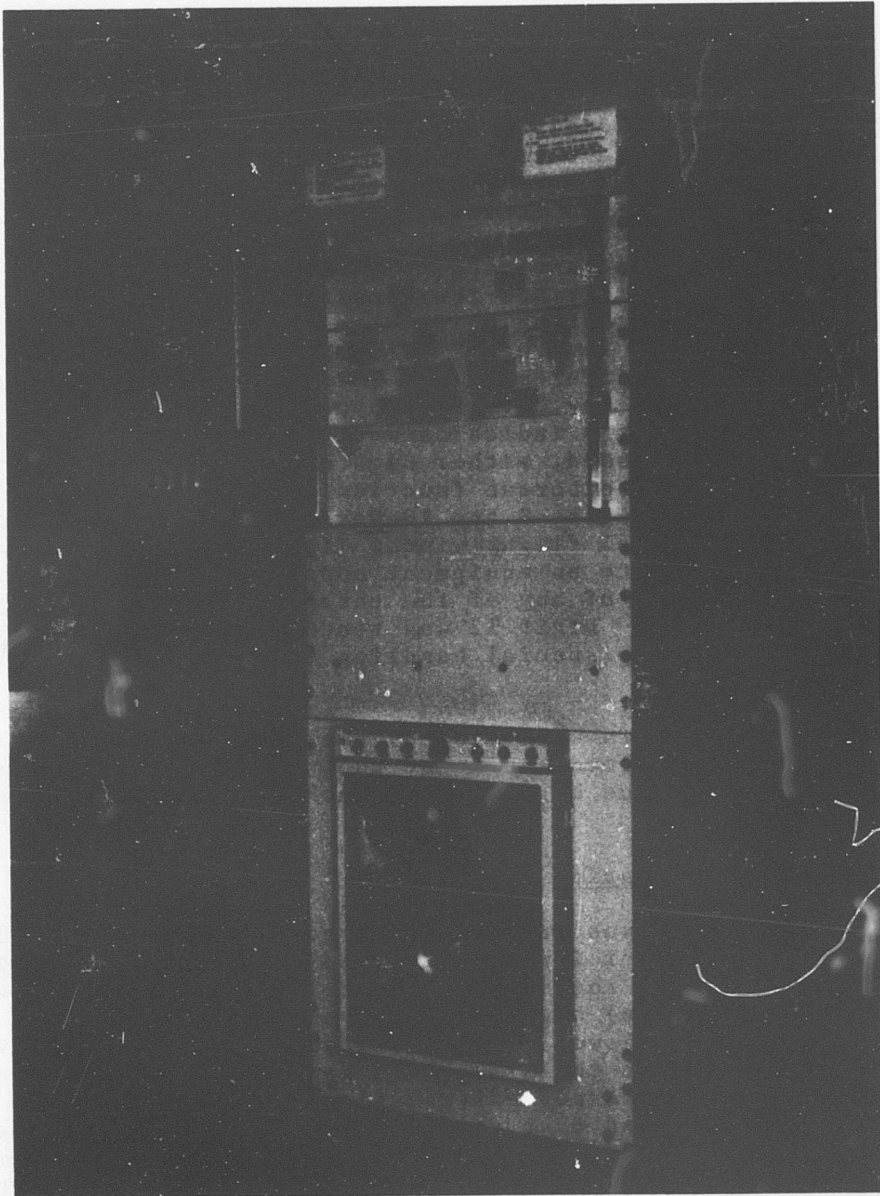
Figure 11. Front View of Portion of Trailer-Mounted Data Preprocessor.

The major elements of the data preprocessor are a datalogger and a 1/3-octave filter bank. Ancillary equipment was designed and built by Melpar.

The data preprocessor is a device that converts 12-second data increments consisting of 14 channels of analog data (plus edge track) into digital data written on conventional 1/2-inch computer-compatible tape. The data preprocessor was designed and built specifically to perform the complex functions required for this program. Figure 11 shows a portion of the trailer-mounted data preprocessor.

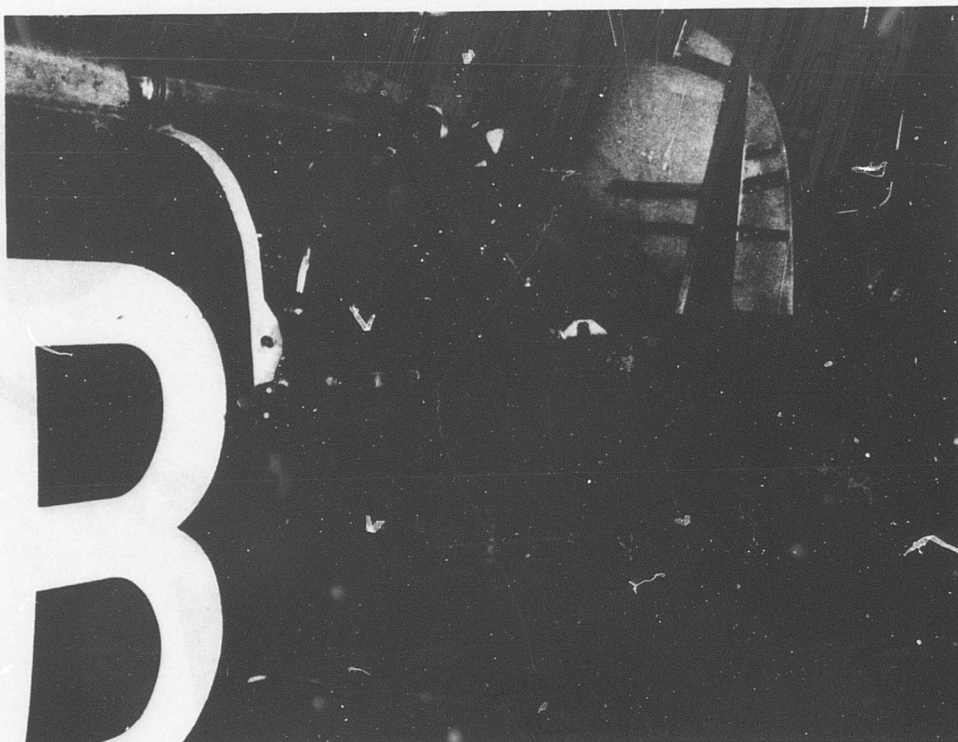
Figure 60. Tail Rotor Drive Shaft - Forward End.

The cables from the drive shaft are routed into the lower compartment through a replacement steel panel made by Melpar. These cables join the cable from the tail boom.
